Energy at Langley Primary School

Energy Audit – What did it identify?

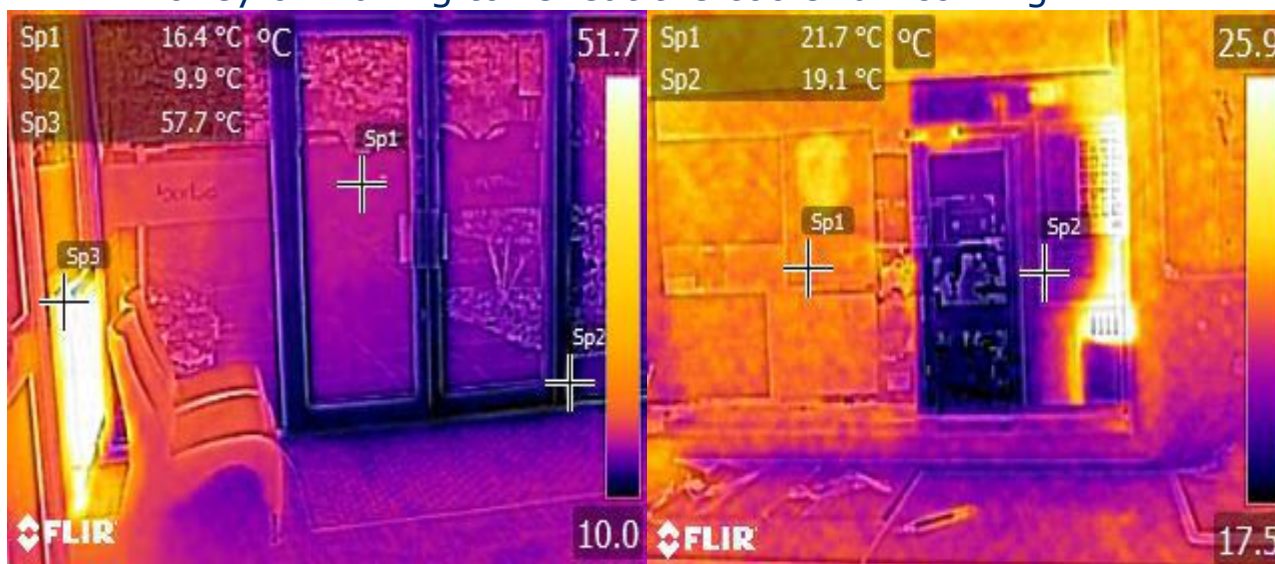
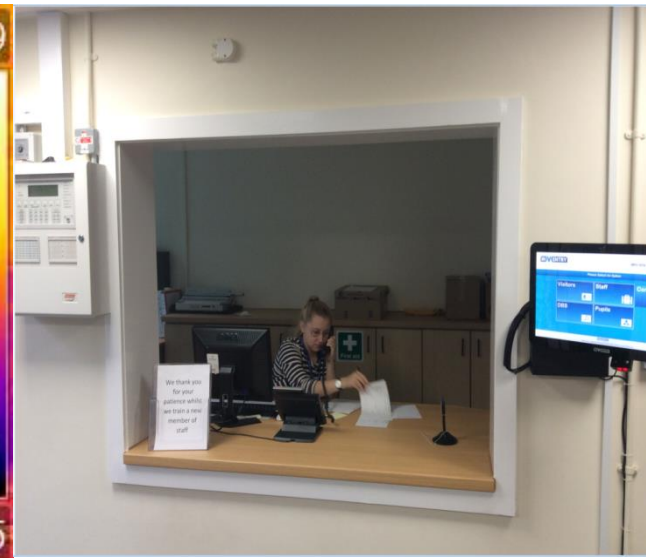
- There is a good “draught lobby” at the entrance of the school: these are spaces with an external door that can be opened and closed before moving to the internal door to open that one. This prevents the cold draught being drawn through into the building and heat lost to the outside.

- Left shows the inside of the external door and is performing pretty well.
- The image on in the middle is from inside the office looking out through the hatch. The left side is the closed glass, the right is the opening to the draught lobby, showing that it is a decent buffer zone and having the lobby cooler than the rest of the school is fine, no need to have it as warm as the School Office. It also shows how the hatch should be kept closed when it can else the coolness will impact the office. There is also a hot radiator in the buffer zone so this could be turned down cooler than the rest of the school

- The right photo shows the new area, admin office no longer exposed to “draught lobby” because a wall has been built across blocking the main office from lobby. The advantage is that no heat from the office is going into the lobby out the front door, this will save money on having to reheat the cooler air coming in.

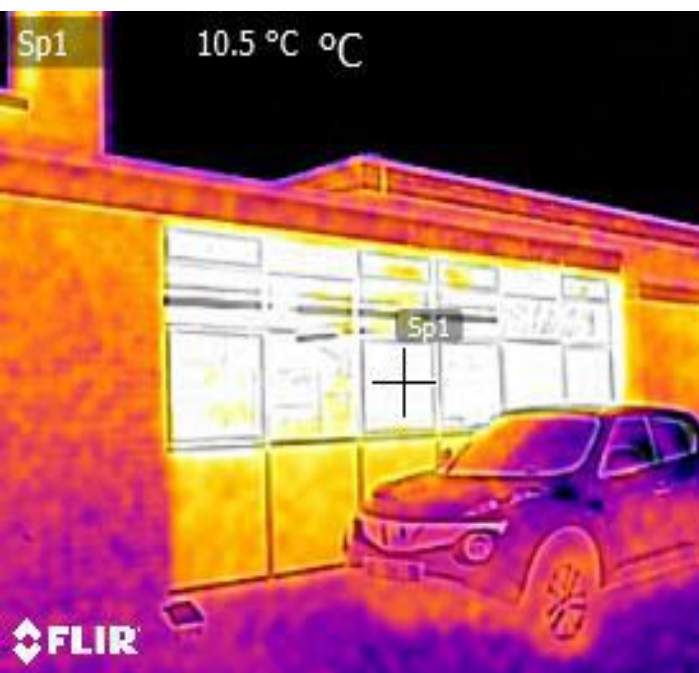
Old single glazed

- Windows in the school are a mix of double-glazed and single-glazed and inevitably the double perform well and the single much worse. The photo below shows singled glazed windows leaking inside heat out .

Installed double glazed windows round the front of the building including the admin office

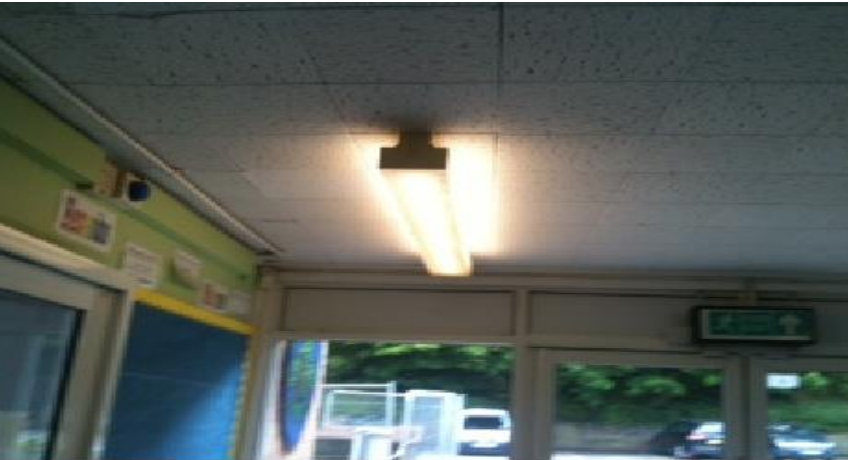
Reception old lights T12 Fluorescents

- **ADMIN OFFICE** - Lighting in reception and admin office is inadequate (T12) fluorescent tubes. These are by today's standards inefficient, dirty, dull and yellow.

**Previously
3 x 5ft T12 Fluorescent
tubes (70 W each)**

Wattage
dropped from
70W to 15W

**NOW
3 X LED lights (15 W)**

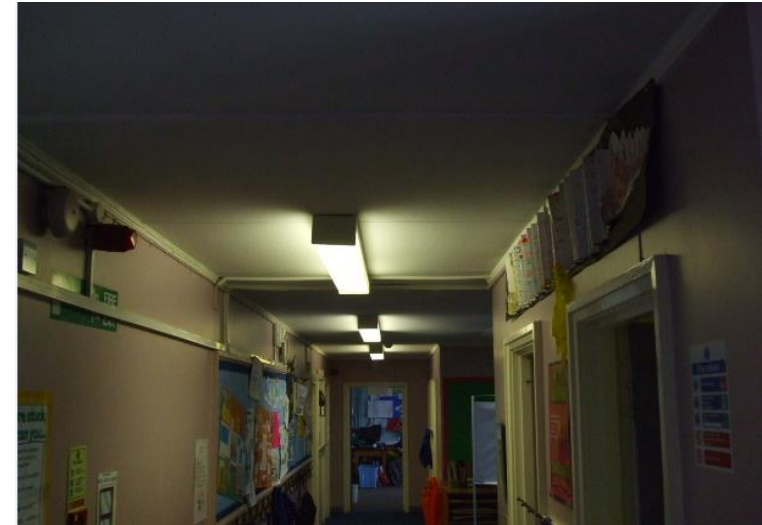
BEFORE – old dark lights

- **CORRIDOR** - Lighting corridor was is inadequate (T12) fluorescent tubes.

Previously
5 x 5ft T12 Fluorescent
tubes (80 W each)

NOW
5 X LED lights round
fittings (15 W)

Wattage
dropped from
80W to 15W

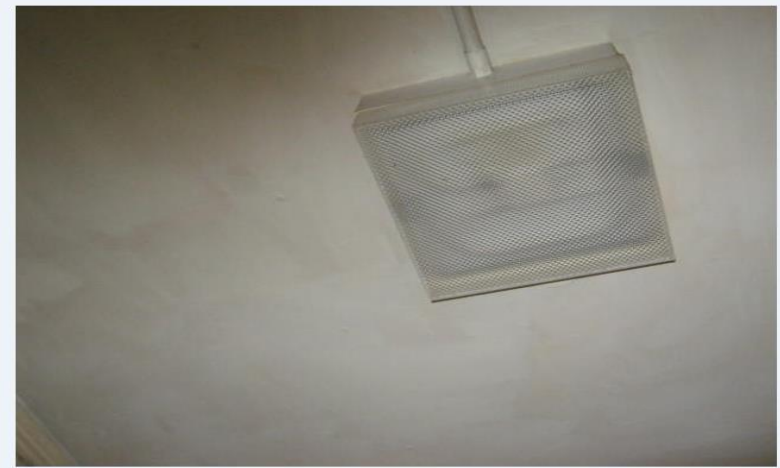
Lights by steps Old – 2D lights

- **Stairs next to hall – (3 steps down)** Lighting was inadequate 2D fluorescent

**Previously
2 x 2D Fluorescent (36 W)**

**NOW
2 X LED lights round
fitting (15 W)**

Wattage
dropped from
36W to 15W

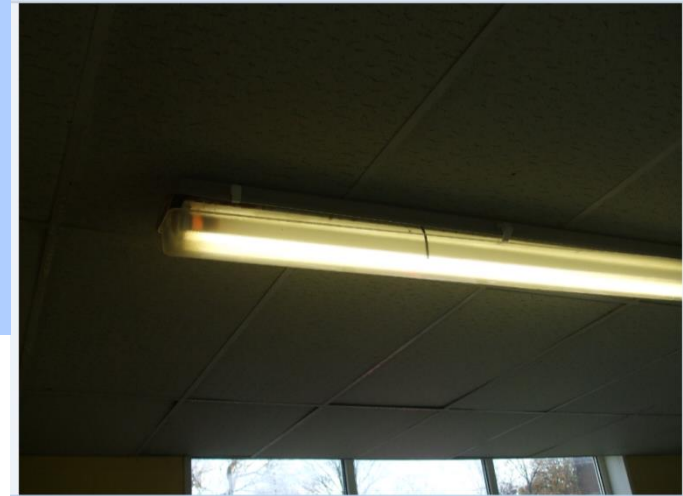
Old Lights

- **Music Room** - Lighting is inadequate (T12) fluorescent tubes.

Previously
9 x 5ft T12 Fluorescent
tubes (80 W each)

NOW
5 X LED lights (15 W)

Wattage
dropped from
80W to 15W
Number of
fittings
dropped from
9 to 5

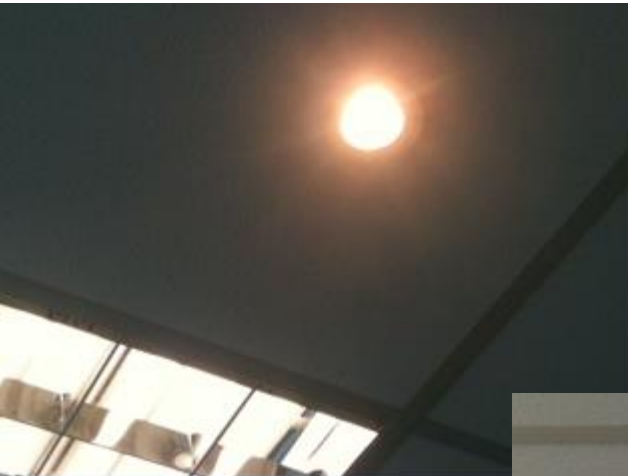
Old spot Lights

- **Small Kitchen-** Lighting kitchen was is inadequate halogen spot lights

**Previously
40 W Halogen spot
lights**

Wattage dropped from
40 W to 5W
20 OLD AND 19 NEW

**NOW
5 W LED spot lights**

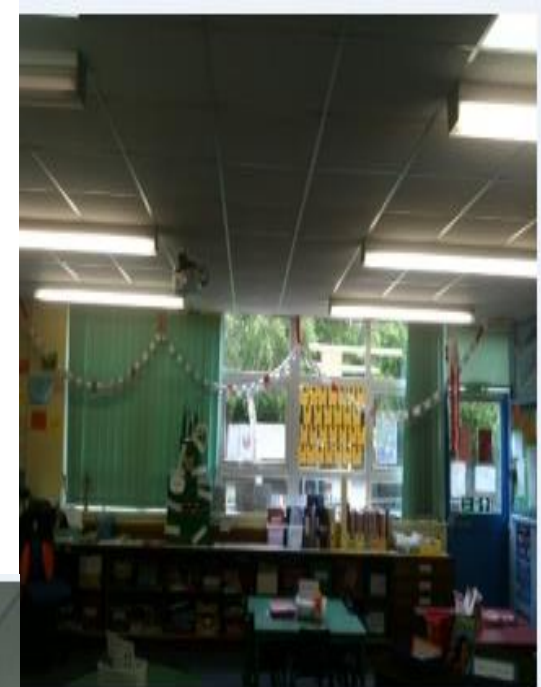
Old Lights - dark

- **Library**- Lighting was old fluorescent tubes

Previously
9 x 5ft T12 Fluorescent
tubes (80 W each)

NOW
5 X LED BATTENS (15 W)

Wattage
dropped from
80W to 15W
Number of
fittings
dropped from
9 to 5
