Energy at Langley Primary School

Energy Audit – What did it identify?

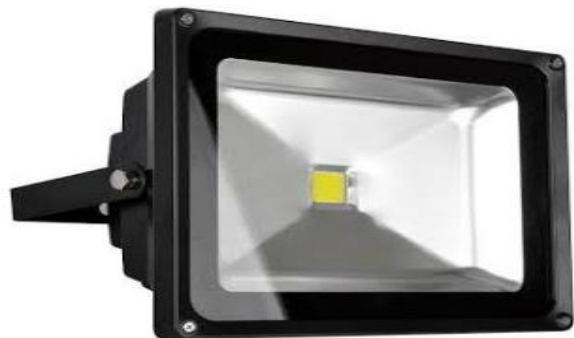
- **CAR PARK** - recommendation change old low pressure sodium halide lights for LED's

Wattage dropped from 250 w to 50 watt

**Previously
8 x sodium low
pressure metal
halide (250 W
each)**

**NOW
8 X LED Lights
(50 W)**

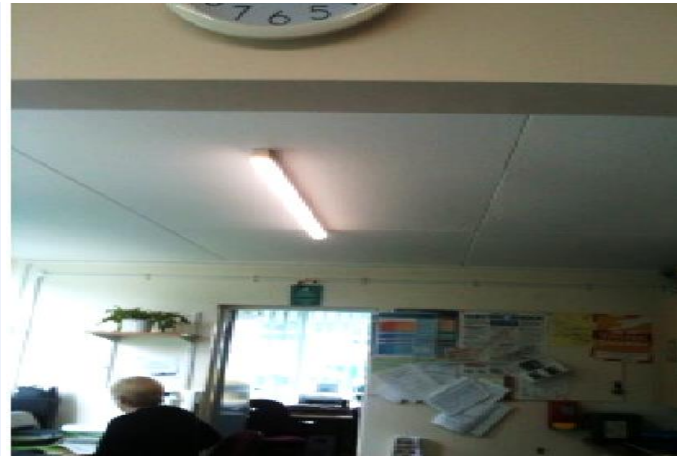
Admin office new LEDS

- **ADMIN OFFICE** - Lighting in reception and admin office is inadequate (T12) fluorescent tubes. These are by today's standards inefficient, dirty, dull and yellow.

Wattage
dropped from
70W to 15W

LED's in admin
have a nice
daylight colour,
flicker free,
reduce risk of
migraine,
potentially save
65%

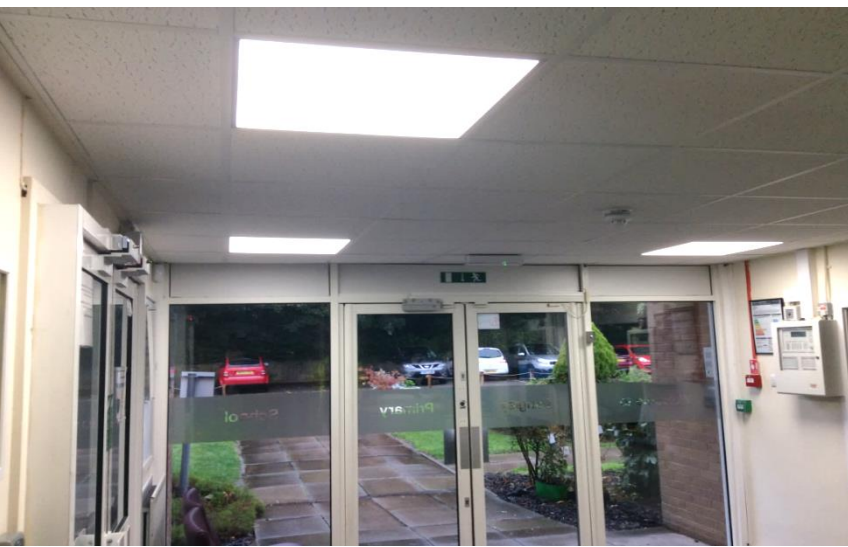
Reception new LED's 2018

**Previously
3 x 5ft T12 Fluorescent
tubes (70 W each)**

**NOW
3 X LED lights (15 W)**

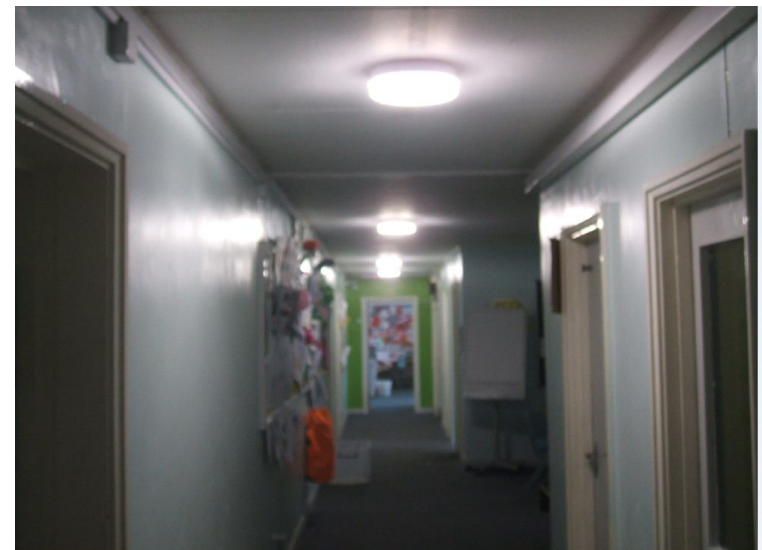
AFTER – new bright lights

- **CORRIDOR** - Lighting corridor was is inadequate (T12) fluorescent tubes.

Wattage
dropped from
80W to 15W

NOW
5 X LED lights round
fittings (15 W)

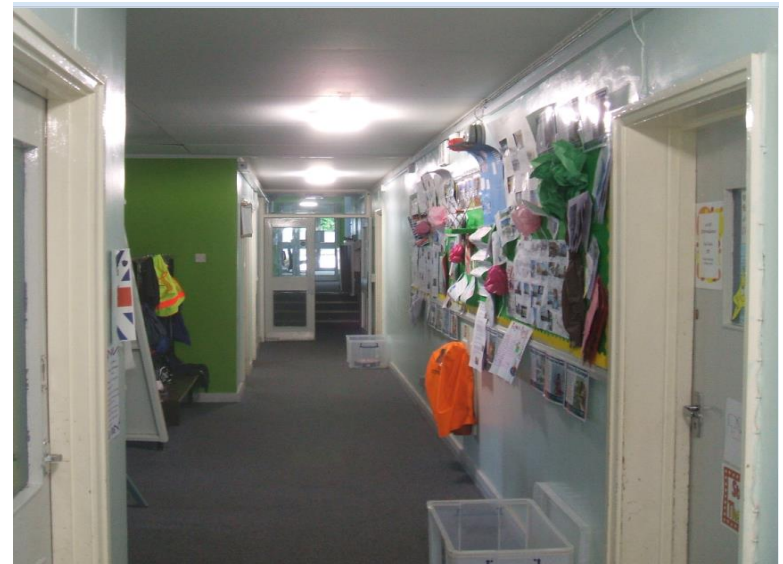
Lights by steps now LED

- **Stairs next to hall – (3 steps down)** Lighting was inadequate 2D fluorescent

Wattage
dropped from
36W to 15W

**NOW
2 X LED lights round
fitting (15 W)**

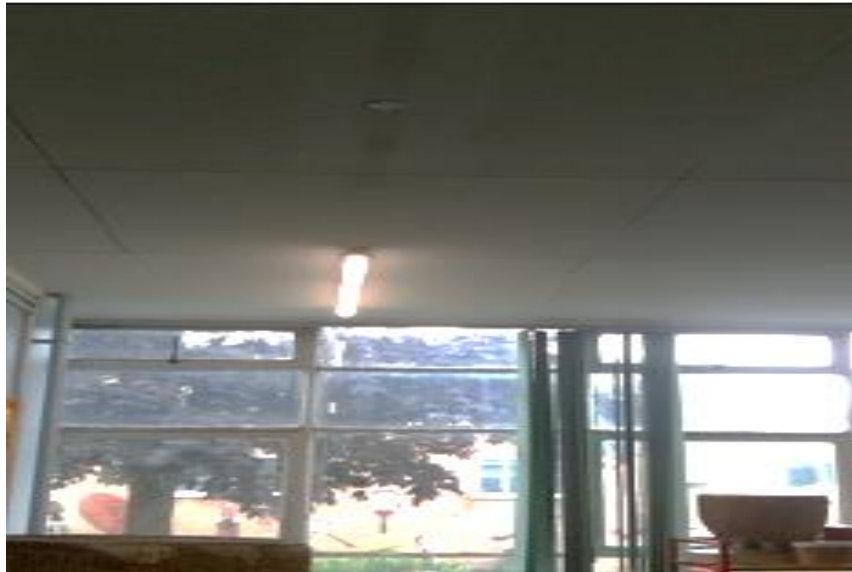
Wattage
dropped from
80W to 15W
Number of
fittings
dropped from
9 to 5

Shows gap where old light was

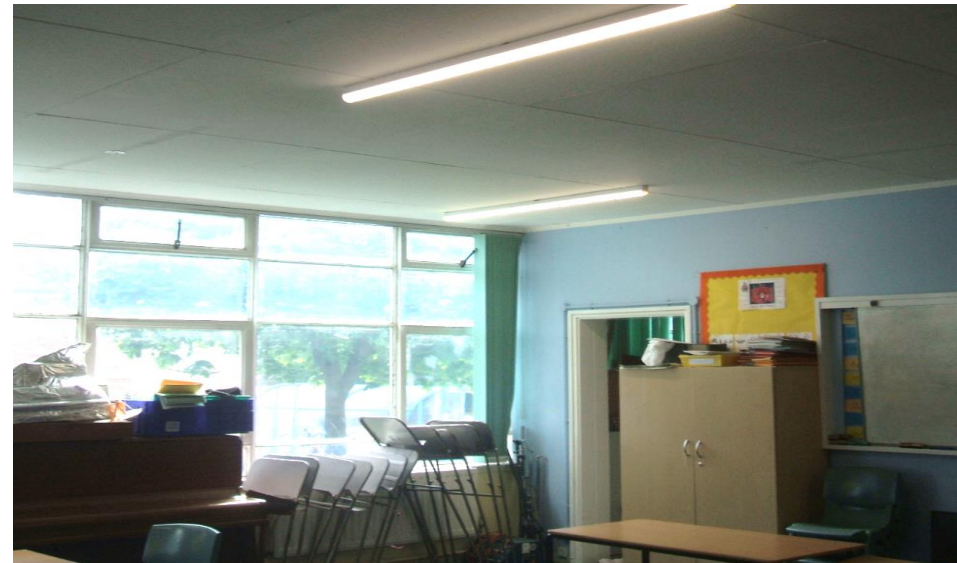
New LEDs

- **Music Room** - Lighting is inadequate (T12) fluorescent tubes.

NOW
5 X LED lights (15 W)

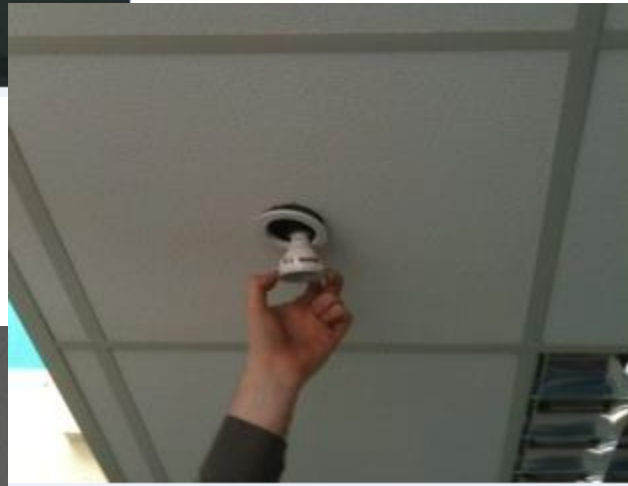
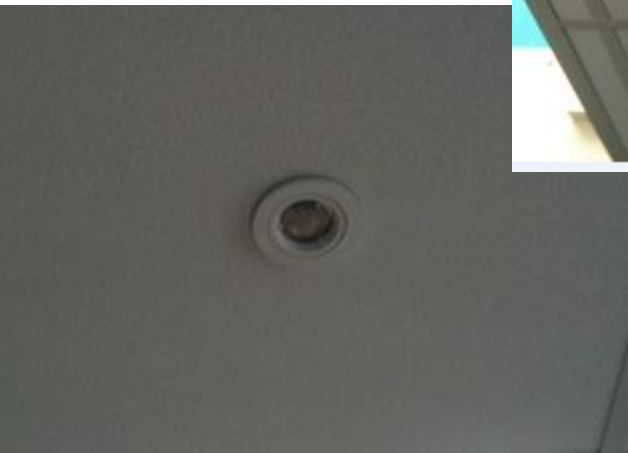
New LED spots

- **Small Kitchen-** Lighting kitchen was is inadequate halogen spot lights

Wattage dropped from
40 W to 5W
20 OLD AND 19 NEW

**NOW
5 W LED spot lights**

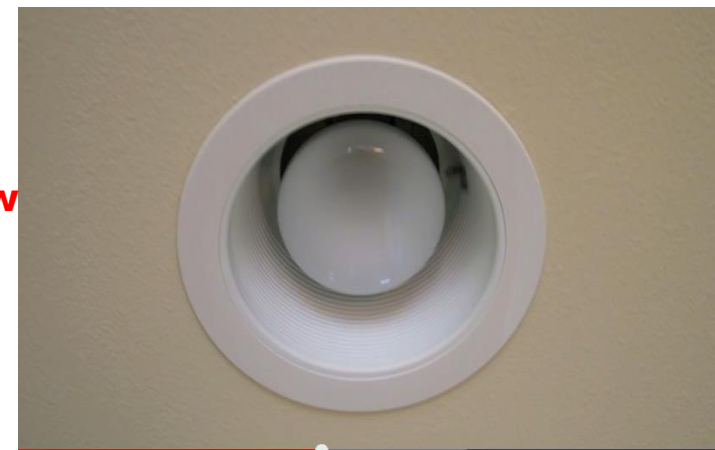
Screw out old screw in new

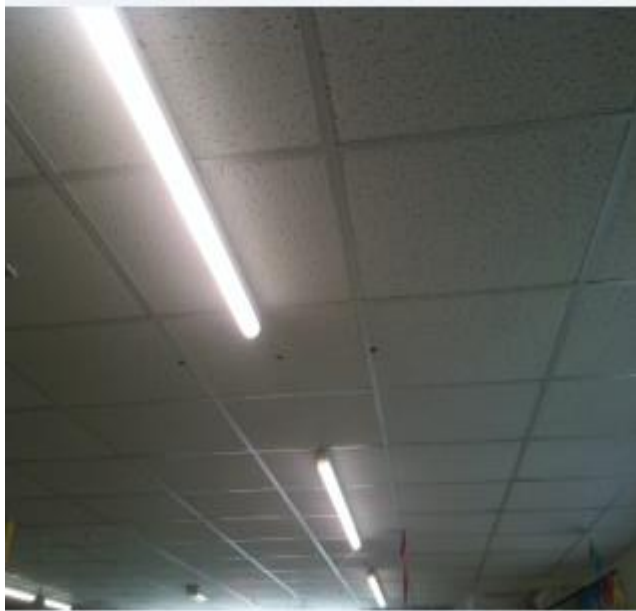
New Lights

- **Library**- Lighting was old fluorescent tubes

Wattage
dropped from
80W to 15W
Number of
fittings
dropped from
9 to 5

NOW
5 X LED BATTENS (15 W)

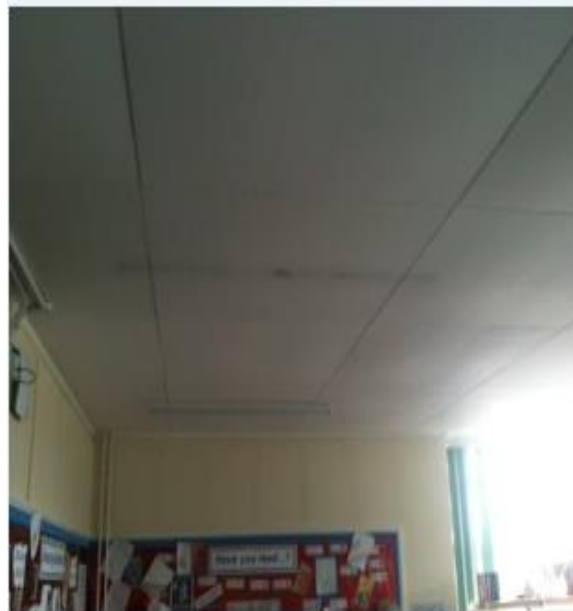
Shows gap where old light removed
